Manhole Inspection Summary

Manhole # S67K__005MH

Insp Date: **6/3/08 9:12 AM**

Location Address: **6130 Gusryan St.**

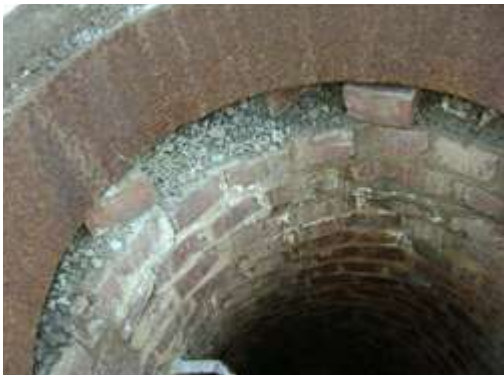
Defect 2

Condition: ☐ Sound ☐ Cracked ☐ Root Intrusion ☒ **Loose Brick** ☒ **Deteriorated**

Infiltration: ☐ None ☒ **Joint** ☐ Cracks ☒ **Mortar** ☐ Roots ☐ Wall

Loose Bricks

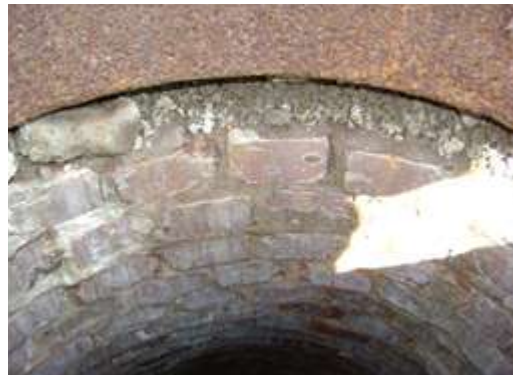
Defect 1

Frame Offset: **1** (in.) Condition: ☐ Sound ☒ **Cracked** ☐ Leaks

Offset

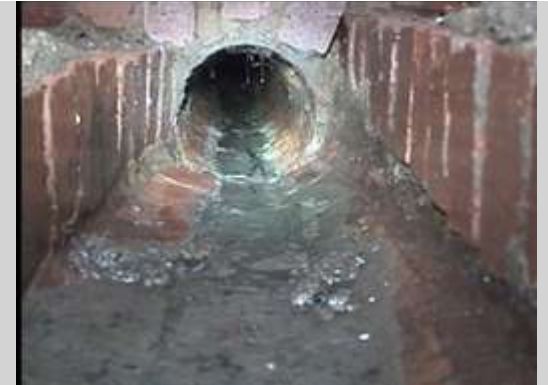
12 O'Clock Outflow

6 in. Circular Gravity Sewer
Pipe Out @ 12 O'Clock

Pipe Height: **6** (in.) Rod and Bar (Angled)
Pipe Material: **Clay** ☐ Pipe Lined
Invert Depth: **7.50** (ft.) Flow Characteristics: **None**
Deposits: ☒ None ☐ Mud ☐ Sludge ☐ **Debris** ☐ Grease
Silt Depth: (in.) Deposits Extent:
Infiltration: **None** Pipe Seal Cond: **Sound**

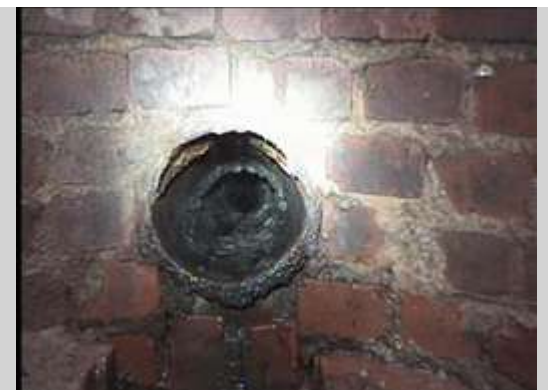
6 O'Clock Inflow

6 in. Circular Gravity Sewer
Pipe In @ 6 O'Clock

Pipe Height: **6** (in.) Rod and Bar (Angled)
Pipe Material: **Clay** ☐ Pipe Lined
Invert Depth: **6.58** (ft.) Flow Characteristics: **None**
Deposits: ☐ None ☐ Mud ☐ Sludge ☒ **Debris** ☐ Grease
Silt Depth: **1** (in.) Deposits Extent: **Medium**
Infiltration: **None** Pipe Seal Cond: **Sound**
